Strathmore Mill Feasibility Study

for the Town of Montague, Massachusetts

May 2005

Finegold Alexander + Associates Inc
Architects and Preservation Planners
Boston, Massachusetts

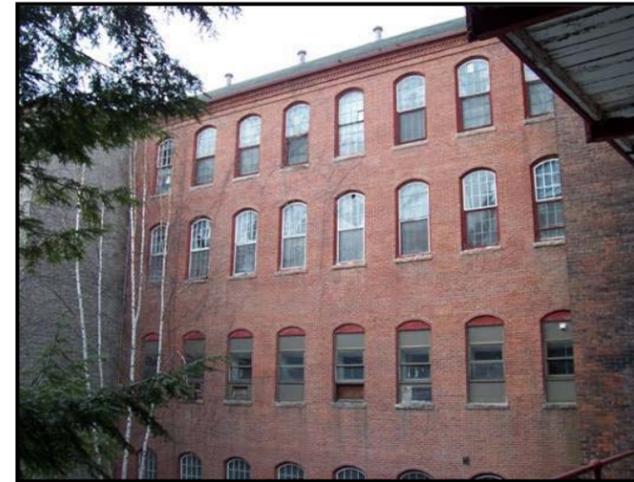
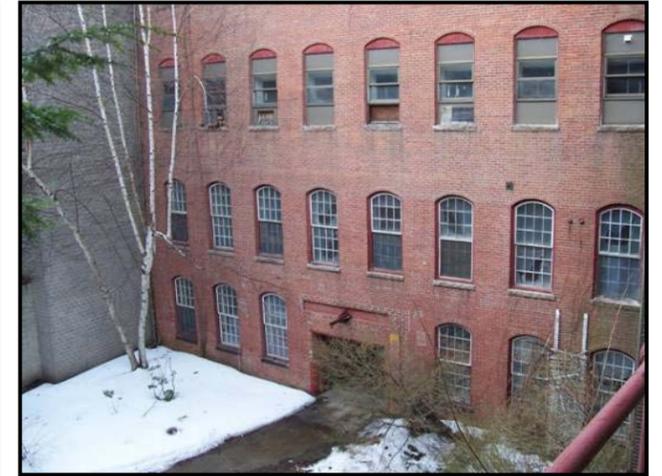
Mr. Jim Slavis, a former building tenant that we contacted, stated that Building Recycling International (BRI) had hired an engineering company to evaluate the buildings when they were considering buying it a few years ago. Mr. Slavis stated that it was his recollection that BRI's engineer determined that the west walls of the buildings along the river were in very poor condition. He stated that he thought that the problem was found to have been caused by water infiltration into the building walls. Mr. Slavis stated that there was a 1-1/2 foot bulge in the masonry wall between the first and second floor where Building No. 1 and Building No. 2 meet. Mr. Slavis estimated the bulge extended horizontally along the face of the wall approximately 8 to 10 feet. Mr Slavis stated that the cement and fiberglass coating was added to the face of the masonry as a means of strengthening the walls. Based on visual observations, it is our opinion that the wall coating is providing very little if any added strength to the wall.

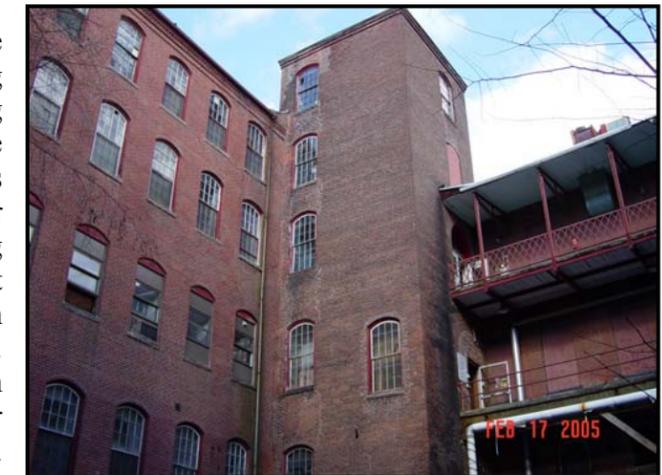
The exterior surface of the west masonry wall above the third floor appears to be in fair to poor condition. The mortar joints that were observed above the third floor appear to be deteriorated. The mortar has been eroded from the brick joints at many locations. In addition, some areas of the brick appear to have moss growing on the face of the brick. This usually indicates that water is infiltrating the wall.

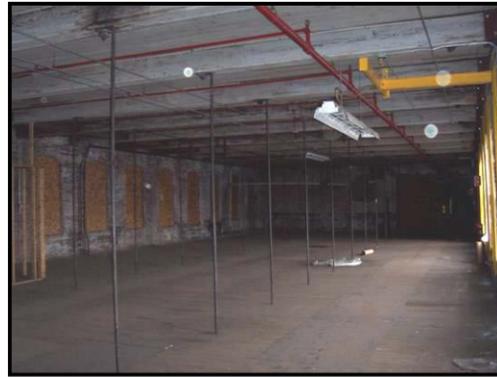
Cracks were observed on the interior of the building on the second floor, in the west masonry wall near the southwest corner of the building. A masonry arch had failed over a window in the west wall of the building. In addition, a saw-toothed crack had formed in the masonry wall below the window. Mr. Slavis stated that these cracks were caused by the collapse of a tailrace that runs diagonally beneath Building No. 1. We did not observe the tailrace during our visual survey and therefore cannot confirm if the tailrace structure collapsed or if it contributed to the cracks observed in the masonry wall. The cracks in the masonry were observed in the same room on the second floor where supplemental steel framing was added to support the floor above.

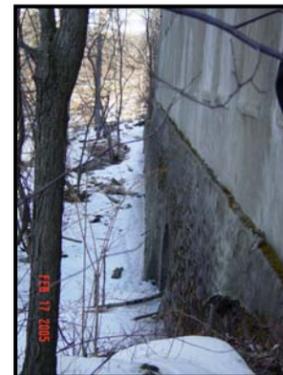
tailrace, exposing the fieldstone wall. The foundation wall was deteriorated at this location; the mortar has eroded from between the stones.

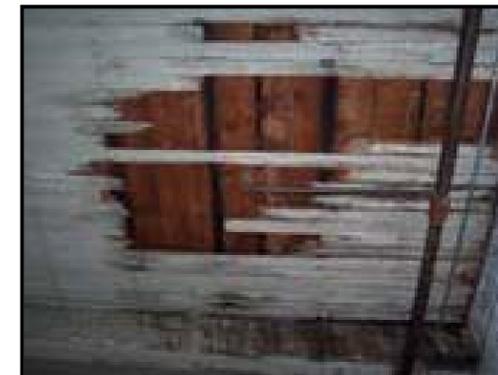
The wood ceiling was deteriorated at several locations on the third floor. The deterioration appears to be from moisture.

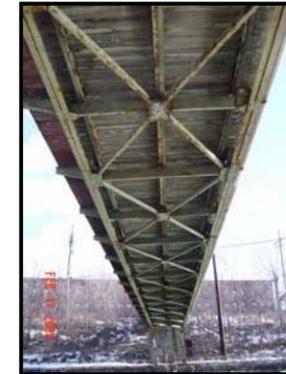
The Strathmore Pedestrian Bridge provides access to the Strathmore Mill from the village of Turner Falls over the Turners Falls canal. The bridge is currently owned and maintained by Northeast Generating Services (NGS). The bridge has a span of 153 feet and is constructed of riveted steel trusses, steel angle cross bracing and a 3-inch wood plank walking surface. A 60 foot long steel framed walkway begins at the Canal Street side of the footbridge and connects to a steel and wood framed staircase that leads down to the pedestrian bridge. On the paper mill side of the bridge, a similar steel and wood framed staircase leads from the end of the bridge down to the entrance to the mill on the fourth floor of Building No. 1. The bridge is currently closed which prevented us from making close observations. NGS had the bridge inspected in 2004 and have provided the report to us for our review. The results of their inspection indicate that the lower chord framing has suffered corrosion and will

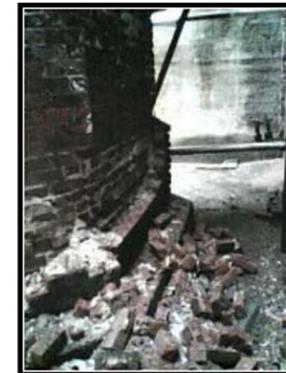
The base of the brick smoke stack, located in the courtyard between Building No. 8 and Building No. 3 is deteriorated. The outer wythe of brick masonry has fallen off the base of the stack. We did not observe any additional deterioration above the base of the stack. However, it should be noted that our observation of the stack was limited to the exterior surface of the stack from the ground. We did not visually observe the interior of the stack.
