Strathmore Mill Feasibility Study

for the Town of Montague, Massachusetts

May 2005

Finegold Alexander + Associates Inc
Architects and Preservation Planners
Boston, Massachusetts

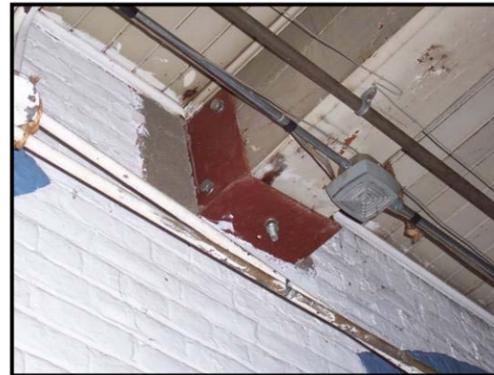
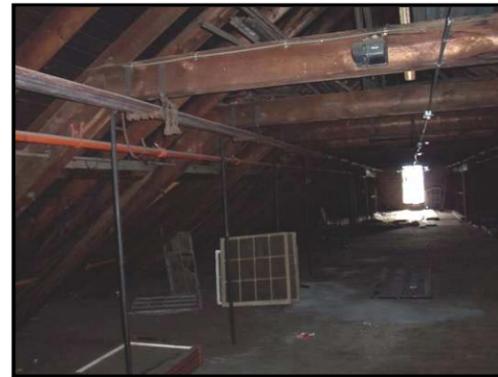
The rods on the fifth floor provide support for the fourth and fifth floor and extend up into the attic where they are attached to the attic roof trusses. The tension rods appear to have been added by the paper mill to increase the live load capacity of the floor. Also, steel plates have been added to the floor beams for the fourth floor where they frame into the brick walls.

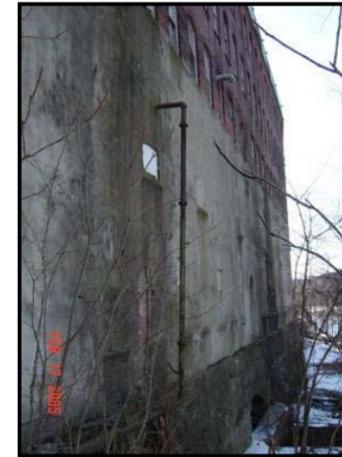
tailrace, exposing the fieldstone wall. The foundation wall was deteriorated at this location; the mortar has eroded from between the stones.

The building exterior is constructed of load bearing multi-wythe brick masonry walls. The west exterior wall has regularly spaced windows on each floor throughout the five stories of the building. Several of the windows have been bricked up. The mortar joints on the exterior face of the building were deteriorated in many locations. Similar to Building No. 1, the exterior surface of the west building wall, from the third floor level of the building down to grade, was covered with a cement and fiberglass coating that prevented us from examining the masonry. As stated above, it is our opinion that the wall coating is providing very little if any added strength to the wall.

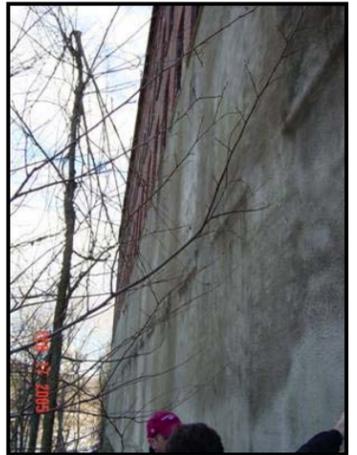
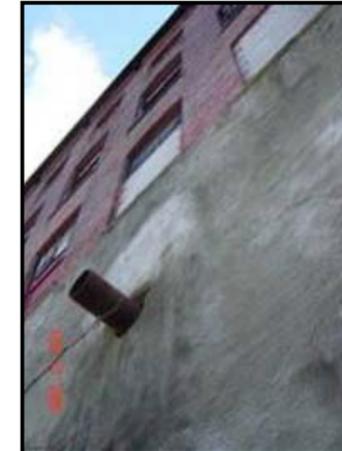
The exterior surface of the west masonry wall above the third floor appears to be in fair to poor condition. The mortar joints that were observed above the third floor appear to be deteriorated. The mortar has been eroded from the brick joints at many locations. In addition, some areas of the brick appear to have moss growing on the face of the brick. This usually indicates that water is infiltrating the wall.

The interior surfaces of the perimeter brick walls are in fair to good condition. The interior brick walls were covered with paint. However, the brick mortar joints were observed to be deteriorated and soft in many locations. When probed with a screwdriver, the mortar disintegrated to a dust.

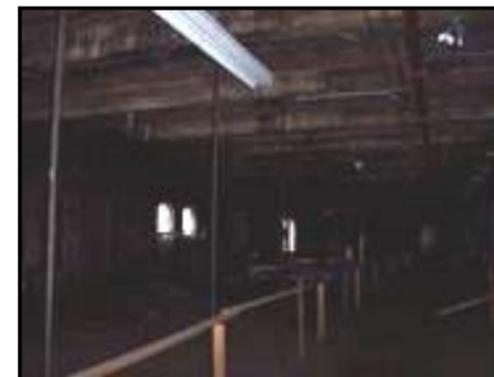
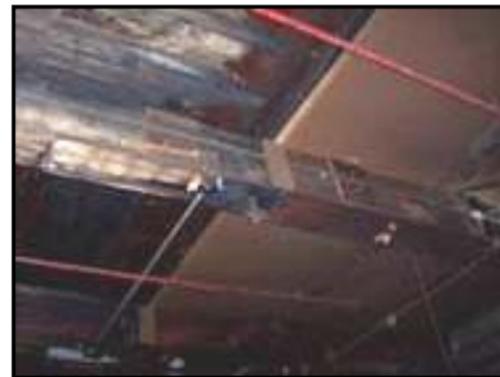
The building floors are constructed of wood and several are topped with concrete. The floors are supported by the masonry walls, a combination of steel and wood framing and interior steel lally columns. The fifth floor has additional floor supports consisting of

tension rods that are equally spaced throughout the length of the building. The rods on the fifth floor provide support for the fifth floor and extend up into the attic where they are attached to steel beams that span between the east and west building walls. The tension rods and steel beams appear to have been added by the paper mill to increase the live load capacity of the floor.

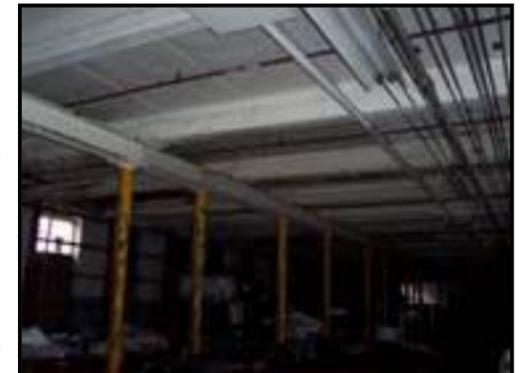
a former Strathmore Mill maintenance foreman that the frame was constructed to prevent fork lifts from hitting the wall while picking up pallets from the floor in this area. We did not see any evidence of damage to the fourth floor beams or masonry wall in this

area and do not believe this framing system was installed for any structural reasons.

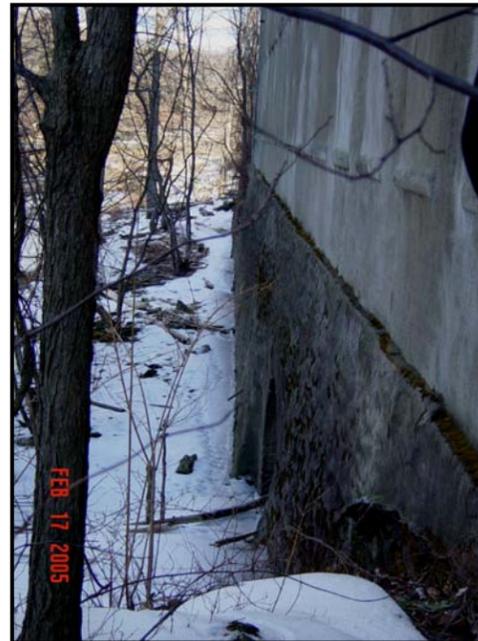
The building exterior is constructed of load bearing multi-wythe brick masonry walls. The west exterior wall has regularly spaced windows on each floor throughout the five stories of the building. Several of the windows have been bricked up. The mortar joints on the exterior face of the building were deteriorated in many locations. Similar to Building No. 1 and Building No. 2, the exterior surface of the west-building wall, from the third floor level of the building down to grade, was covered with a cement and fiberglass coating that prevented us from examining the masonry. As stated above, it is our opinion that the wall coating is providing very little if any added strength to the wall.

The exterior surface of the west masonry wall above the third floor appears to be in fair to poor condition. The mortar joints that were observed above the third floor appear to be deteriorated. The mortar has been eroded from the brick joints at many locations. In addition, some areas of the brick appear to have moss growing on the face of the brick. This usually indicates that water is infiltrating the wall.

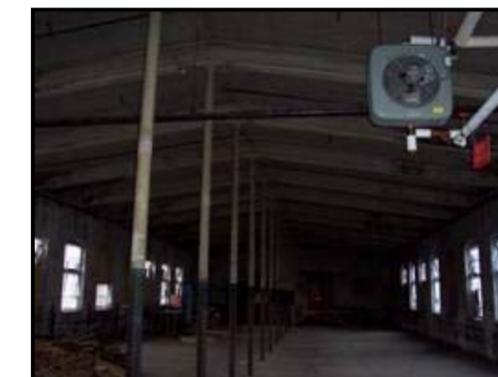
The wood ceiling was deteriorated at several locations on the third floor. The deterioration appears to be from moisture.

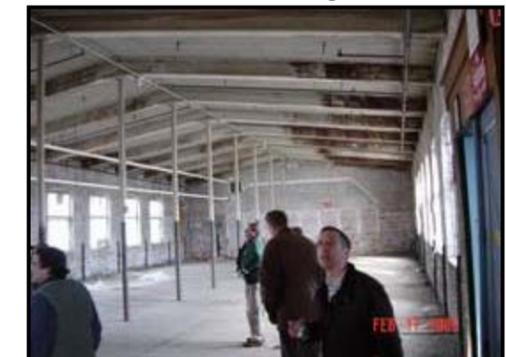
The roof framing for the building consisted of timber beams and wood planking. The timber beams span east to west and are equally spaced throughout the length of the building. The beams are supported by the east and west masonry walls and steel lally columns located in the middle of the floor. The framing appears to generally be in fair condition. We observed evidence of possible water damage on some of the roof beams. The roofing consists of a membrane roofing system that is approximately 20 to 25 years old.

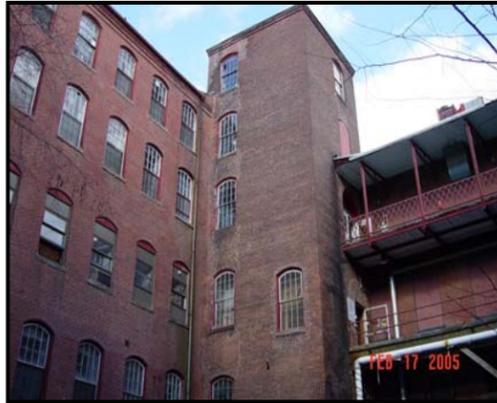
The building exterior is constructed of load bearing multi-wythe brick masonry walls. The mortar joints on the exterior of the building were deteriorated in many locations. The south exterior wall has covered walkways that extend along the exterior face of the third and fourth floor of the building to provide access to Building No. 1 from the canal road level or pedestrian bridge level.

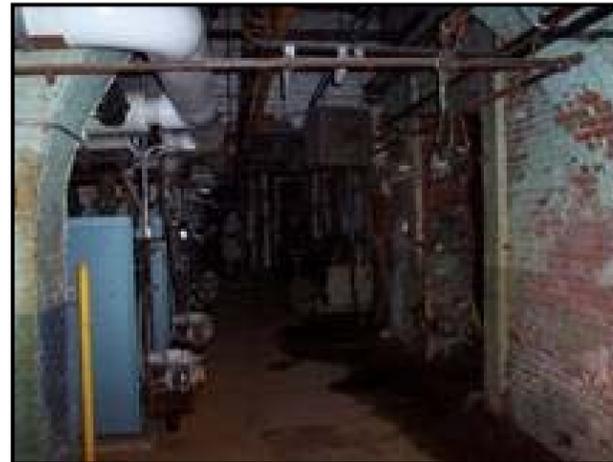
The building walls consist of multi-wythe load bearing brick masonry. The first floor of the building, which is located two stories below the canal road, houses the boilers. The boilers extend from the first floor up to the third floor. Catwalks located above the first floor provide access between the boilers. The building does not have a second floor.

The brick walls are covered with paint. However, the brick mortar joints were observed to be deteriorated and soft in many locations.

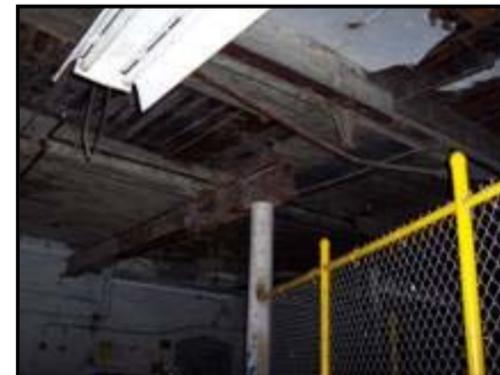
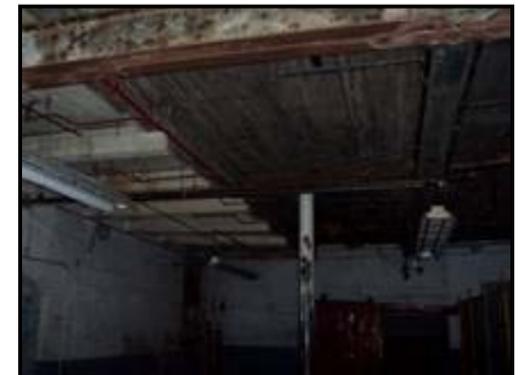
The building floors are constructed of wood and are topped with concrete. Steel beams encased in brick masonry arches support the third floor. Masonry walls, a combination of steel and wood framing and interior steel Lally columns, support the fourth floor.

The roof framing consists of timber beams, wood plank and steel columns. The roofing consists of a membrane roofing system that is approximately 20 to 25 years old.

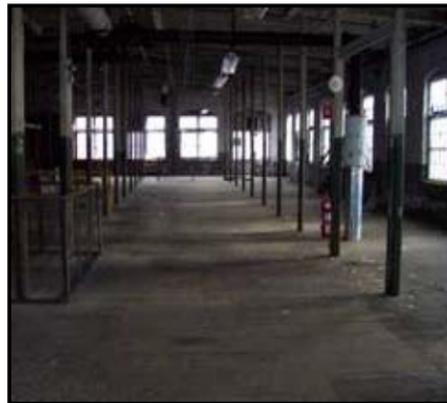
The building third floor exits to the canal road on the east side of the building. The first and second floors are located below grade at the east end of the building and the first floor is on grade at the west end of the building. A storage and loading dock structure has been added on to the north side of the building.

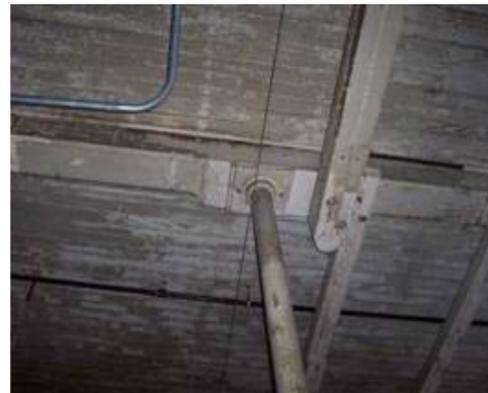
The building floors are constructed of wood and are topped with concrete. Steel beams encased in brick masonry arches support the second and third floors. In addition, brick piers provide additional support for the third floor. The fourth floor is supported by the masonry walls, steel framing and interior steel lally columns.

The roofing consists of a membrane roofing system that is approximately 20 to 25 years old.

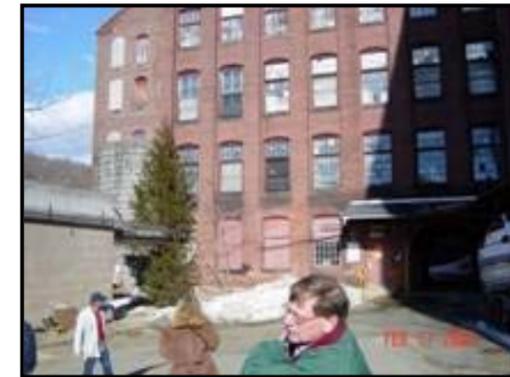
The building exterior is constructed of load bearing multi-wythe brick masonry walls. The north and south exterior walls have regularly spaced windows on each floor throughout the buildings 4-stories. The mortar joints on the exterior of the building were deteriorated and have been eroded from the brick joints at many locations. The brick wall adjacent to the canal has missing and deteriorated bricks. Efflorescence stains are also

visible on the masonry wall, indicating the water is washing the soluble salts out of the mortar. In general, the exterior surfaces of the brick walls are in fair condition for the age of the building.

For the Strathmore Mill Complex, we recommend that all of the building exterior walls be re-pointed. Although this represents a very significant work effort, repairs of some type are recommended for virtually all of the exterior walls. Since erecting staging, which is necessary for most of the repairs, represents a very significant portion of the repair cost, it is prudent to maximize the value of the staging by performing all of the masonry repairs at once.

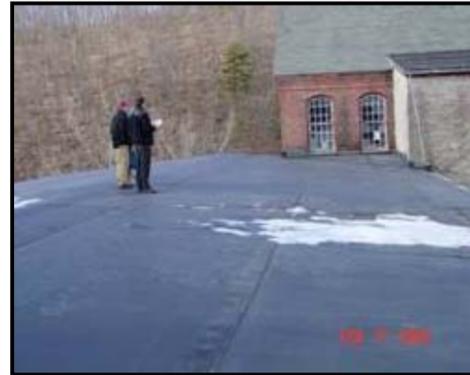
The roof framing for the building consisted of timber beams supported by steel lally columns. The framing is in relatively good condition. The roofing consists of a membrane roofing system that is approximately 20 to 25 years old. Several seams and patches were observed in the roofing membrane.

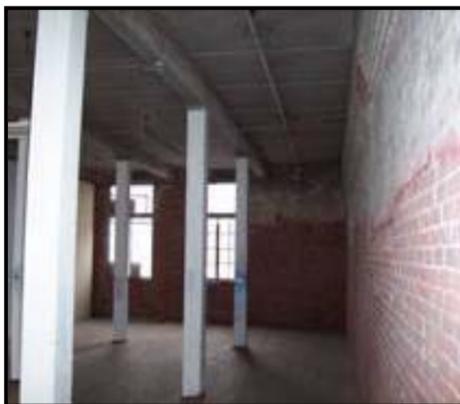
The interior surfaces of the brick walls are in fair to good condition, especially above the third floor. The interior brick walls were covered with paint. However, the brick mortar joints were observed to be deteriorated and soft in many locations. A few brick walls on the upper floors were furred out with gypsum board and could not be seen.

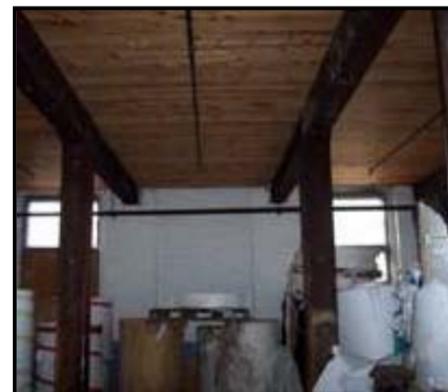
The wood flooring on the second floor was damaged in a few locations. In addition, the wood ceiling was deteriorated in several spots.

The roofing consists of a membrane roofing system that is approximately 20 to 25 years old.

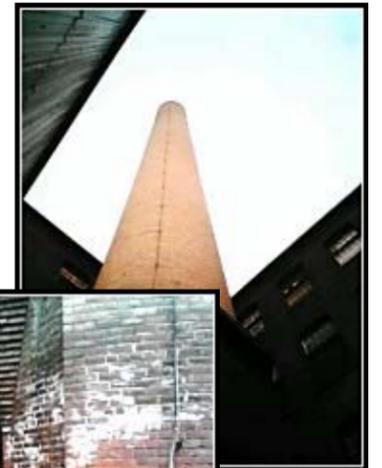
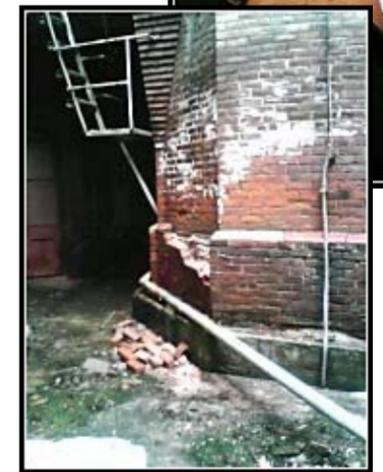
The base of the brick smoke stack, located in the courtyard between Building No. 8 and Building No. 3 is deteriorated. The outer wythe of brick masonry has fallen off the base of the stack. We did not observe any additional deterioration above the base of the stack. However, it should be noted that our observation of the stack was limited to the exterior surface of the stack from the ground. We did not visually observe the interior of the stack.

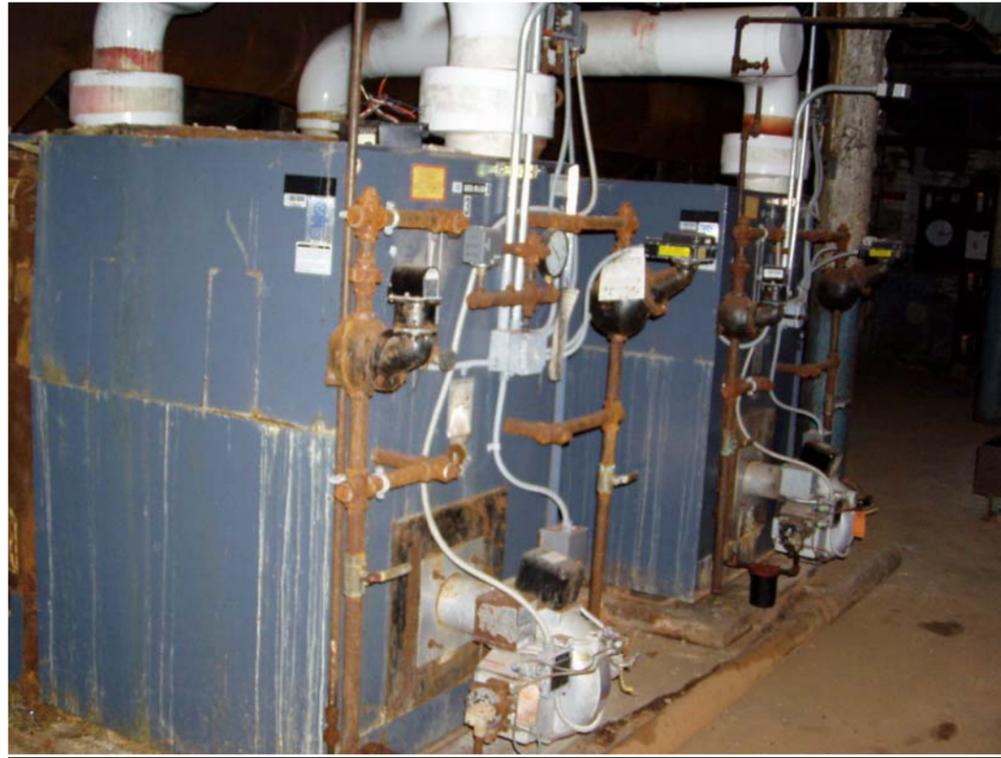
Figure 1 - Weil McLain Boilers

The Strathmore is served by a steam heating system. There is an existing boiler room located in Building 5/6. There are currently four oil fired boilers, two (2) HB Smith 28A-8, 1,500 MBH output each, and two (2) Weil McLain 888, 1,904 MBH output each. The Weil McLain boilers appear to be in poor condition. The HB Smith boilers appear to be newer than the Weil McLain boilers. Mr. Lete indicated that when he left the facility in 1990 only one or two of the boilers was functioning properly. Mr. Clark indicated that he believed International Paper installed two new boilers in 2000 or 2001. Based on our observations, the HB Smith boilers are the new boilers. It is our understanding that the heat has been maintained in the facility by these boilers, but it is unclear if both or only one of the boilers is functioning, although both appear to be operable.

If the existing boilers and steam piping system are to be used to maintain heat in the building, a thorough review of the boilers, piping and steam traps should be performed by a qualified mechanical contractor and boiler technician. Any leaks in the piping should be repaired and the boilers cleaned and tested. The existing oil tank, oil piping, and leak detection systems should also be thoroughly reviewed and tested.

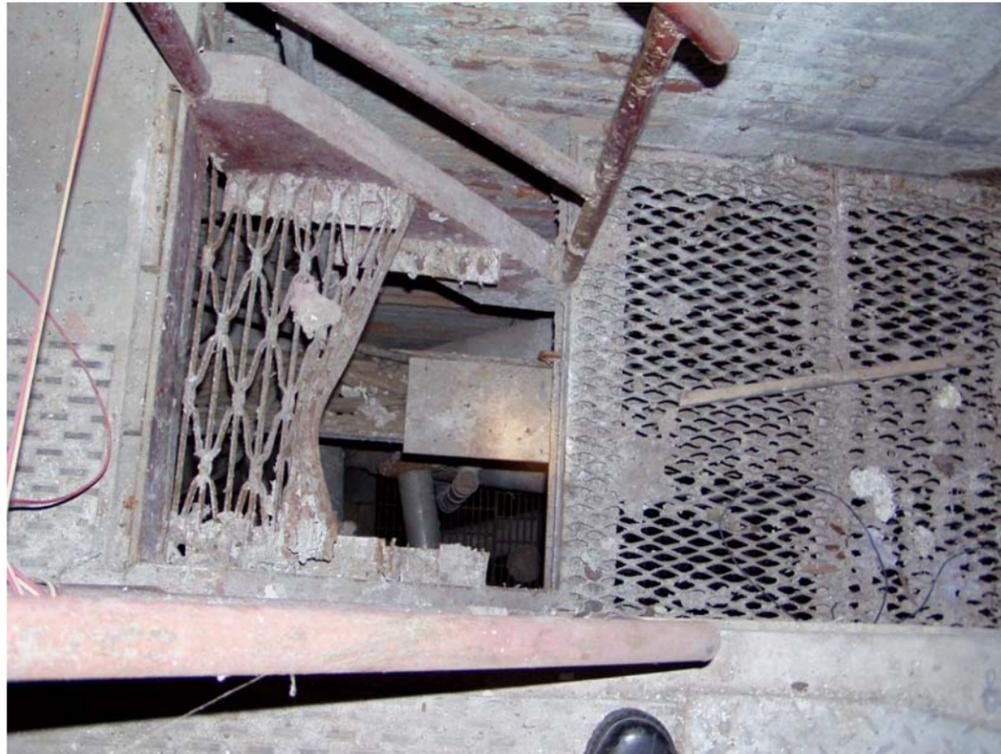
Figure 7 - Underground Waterway

While in the basement of Building #1 and #2 we noted an underground waterway. Mr. Lete explained that this is a weir box, which is part of the canal seepage system. Mr. Lete believes the canal seepage system runs to the river. Mr. Trombley believes the canal seepage system or some portion of it may

run to the lift station, and would recommend separation because the sanitary charges for the Strathmore are based on the flow from the lift station.

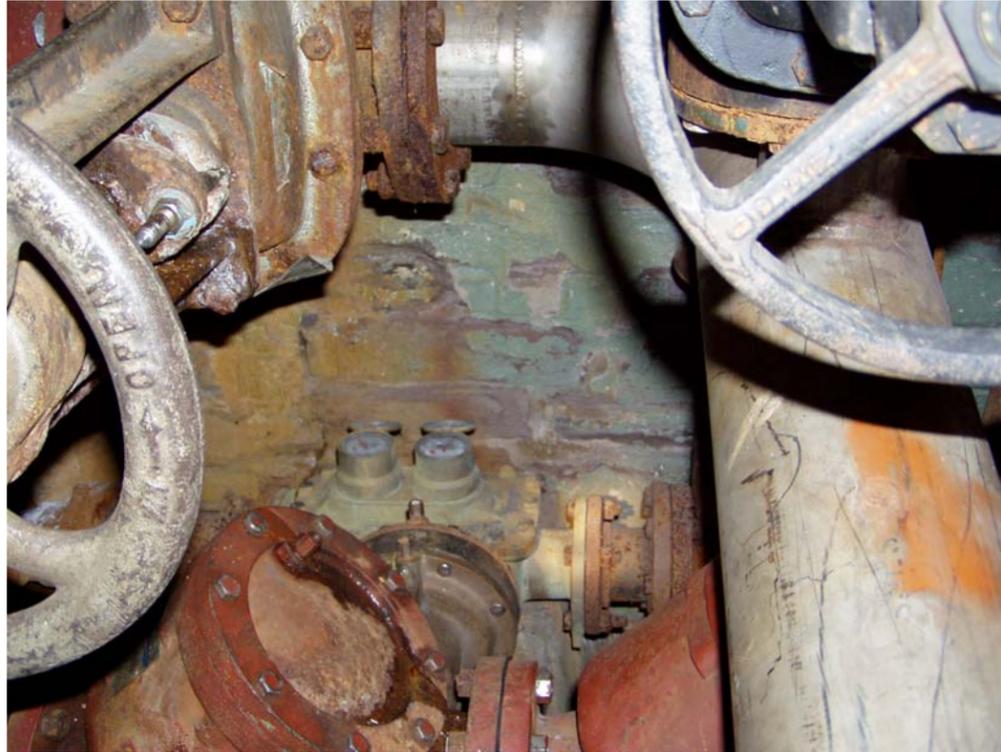
Figure 9 - Water Meter in Building 4 Valve Room

There is an existing 8” domestic water line that enters Building 4. Given the apparent age of the domestic water piping, it likely has lead soldered joints. The piping to serve the rehabilitated areas would begin back before the meter in the valve room in Building 4. The new system can be individually metered by tenant, building or whatever is most appropriate for the new occupancy. The existing water service should be large enough for any of the proposed occupancies.

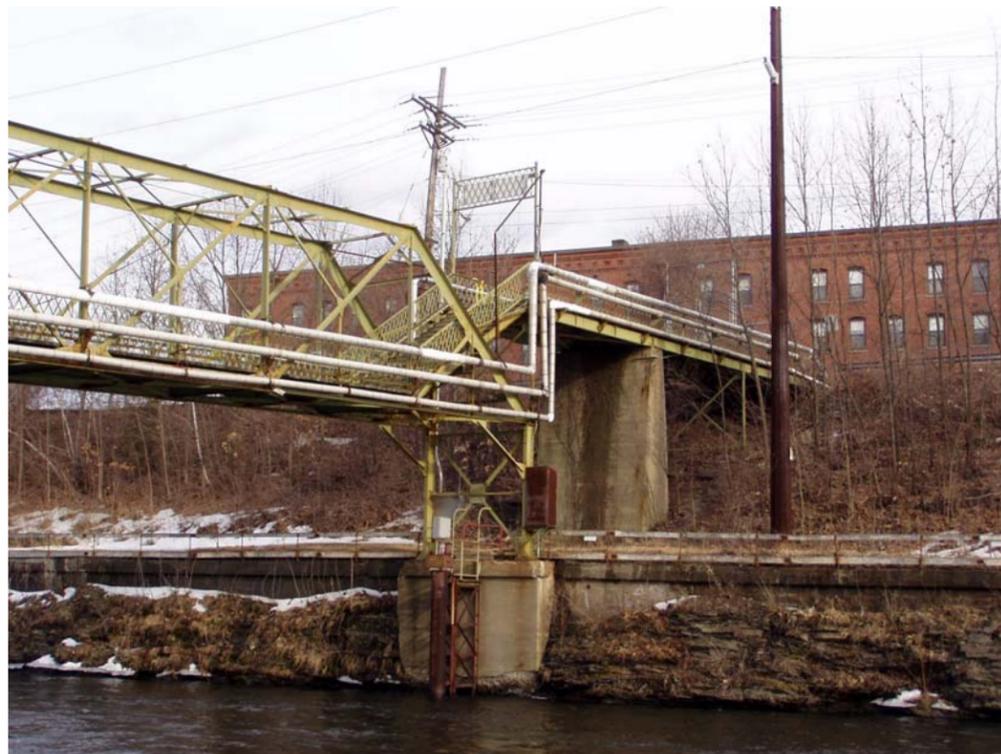
Figure 11 - Utilities Crossing Pedestrian Bridge

Based on drawings provided by the Town, we have determined that the sprinkler system is served by two 8” water lines connected to the town water system. The first line comes from Canal Street and crosses the pedestrian bridge. The 8” pipe crossing the bridge is contained in a boxed enclosure which is in a poor state of repair. Mr. Michael Brown, the Superintendent of the Turners Falls Water Department, indicated

that the line froze recently, is currently broken, and is shut off on the Canal Street side of the bridge and is not functional.

The sanitary discharge from the building flows to a lift station located behind Building #10, from which the effluent is pumped over the pedestrian bridge to a sewer line in Canal Street. Mr. Trombley believes that the pumps and discharge line across the bridge are in poor condition. Mr. Lete stated that the pumps were replaced around 1998, but that the line across the bridge dates back to the 1950’s. We could not view the pumps during the site survey. It is our understanding that the Esleek Building and water treatment plant are not connected to the lift station. We were unable to determine if the Indeck Building is connected to the lift station, but we did see sanitary pipes labeled as being from the Indeck Building. We have also been told by Mr. Clark that the sanitary drainage for the hydro plant is served from the Strathmore sanitary system.

The fact that the 8” water line crossing the pedestrian bridge is inactive creates a potential safety issue for the building that needs further investigation. The original sprinkler design may have required both 8” lines in order to provide adequate flow for the system. The 8” line crossing the bridge should be repaired or the sprinkler system should be recalculated to ensure that the system will operate as designed.
